Manhole Inspection Summary

Manhole # S05SS1002MH

Location Address: **5503 MAGNOLIA AVE**

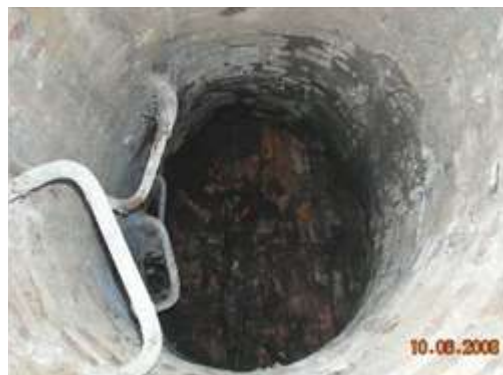
Top View

Channel debris.

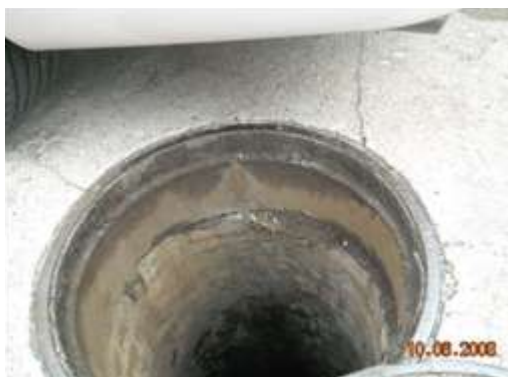
Defect

Frame leaks. Adjustment deterioration and infiltration. Barrel infiltration.

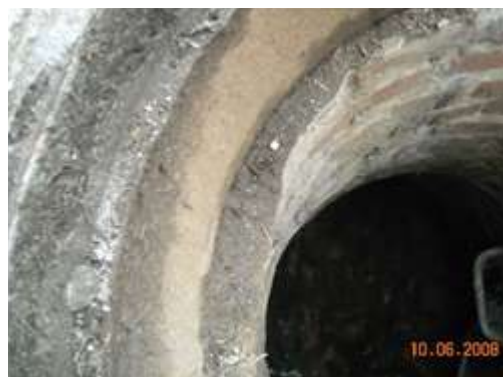
Defect

Frame leaks. Frame offset. Adjustment deterioration and infiltration.

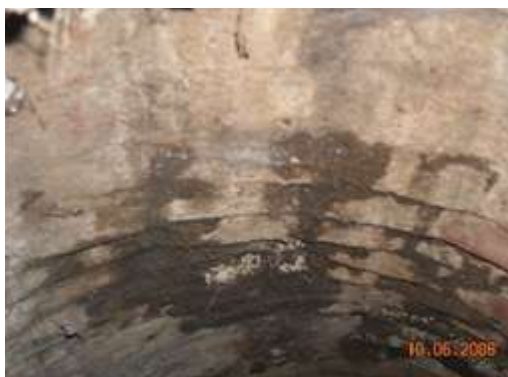
Defect

Barrel infiltration.

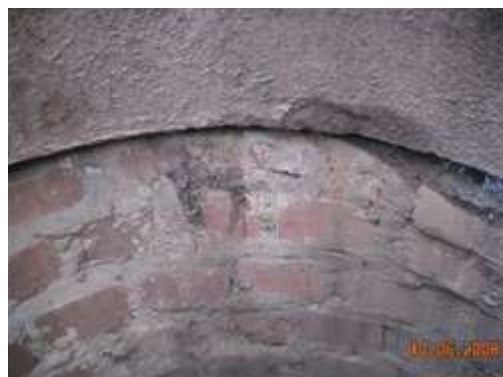
Defect

Frame leaks. Corbel deterioration and infiltration.

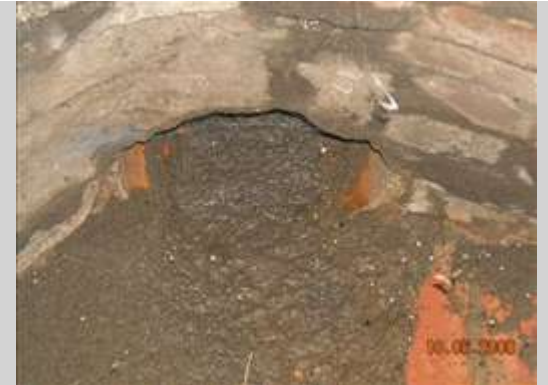
8 in. Circular Gravity Sewer
Pipe Out @ 12 O'Clock

Deposits: ☐ None ☒ **Mud** ☐ Sludge ☐ Debris ☐ Grease

Silt Depth: **1** (in.) Deposits Extent: **Light**
